## LASER PHOTOTHERMOACOUSTIC MICROSCOPY VERIFICATION

Wolkenstein S. S.<sup>1</sup>, Khmyl A. A.<sup>2</sup>, Kerentsev A.F.<sup>3</sup>, Kovalchuk N.S.<sup>3</sup>, Solovjov J.A.<sup>3</sup>, Rubtsevitch I.I.<sup>3</sup>

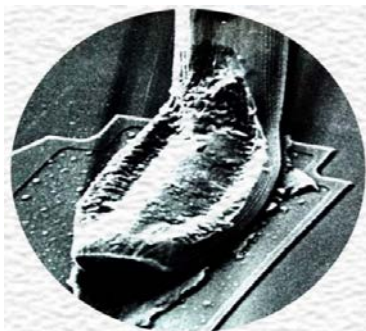
Figure 1 – Typical exterior view of the ultrasonic microbonded wire connection

In the course of inspection performed on microbonded connections (fig. 1) was caught essentially different sight of the resultant laser photoacoustic topograms (fig. 2, 3) of two extreme kinds: unsatisfactory (fig. 2) and satisfactory connection quality (fig. 3).
